**MERRIMACK RIVER BASIN
LACONIA, NEW HAMPSHIRE**

AVERY DAM

**PHASE I INSPECTION REPORT
NATIONAL DAM INSPECTION PROGRAM**

NOVEMBER 1978

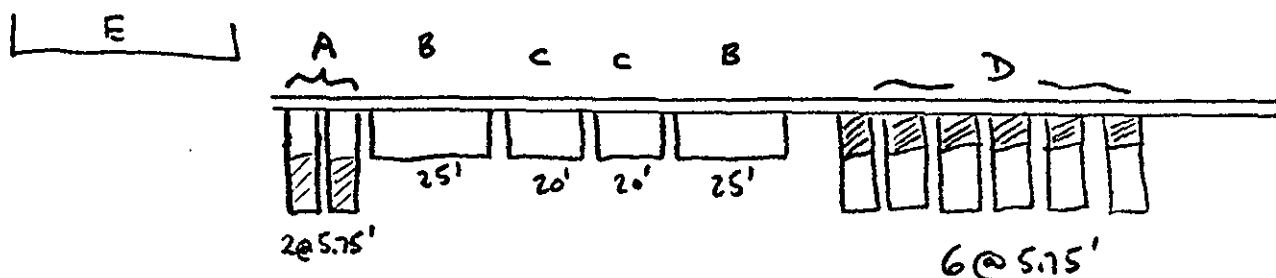
- A: TWO STOPLOG BAYS 5.75' WIDE WITH INVERT AT 484.5 MSL AND MAX. OPENING OF 11.0 FT. NORMALLY STOPLOGS ARE IN PLACE TO ELEV. 491.5 BUT SINCE DAM IS WELL TENDED AND IN CENTRAL ACCESSIBLE LOCATION WE ASSUME THAT THE TOP 3.0 FEET OF STOPLOGS ARE REMOVED DURING TEST FLOOD. THUS CREST WILL BE AT 488.5
- B. TWO SPILLWAY CRESTS 25.0' LONG. NORMALLY RIGGED WITH FLASHBOARDS WHICH ARE ASSUMED TO BREAK FOR TEST FLOOD. CREST AT 488.25'
- C. TWO SPILLWAYS WITH HINGED LEAF GATES IN CREST. GATES ASSUMED TO BE DOWN WHICH RESULTS IN CREST ELEVATION OF 488.25' LENGTH OF EACH SPILLWAY IS 20.0'
- D. SIX UNDERFLOW SLUICE GATES WITH ELECTRIC AND MANUAL LIFTING STEMS. MAX. OPENING IS 5.0' HIGH, 5.75' WIDE; INVERT OF GATES IS 484.5
- E. LOW AREA ON WEST BANK OF RIVER, \approx 400' UPSTREAM OF DAM. ASSUME A WEIR 200' LONG AT ELEVATION 495'.
